**HABITAT ADVISORY VISIT TO THE EWELME  
STREAM, EWELME/BENSON OXFORDSHIRE  
UNDERTAKEN BY VAUGHAN LEWIS,  
WINDRUSH AEC LTD ON BEHALF OF WILD  
TROUT TRUST  
MARCH 2021**

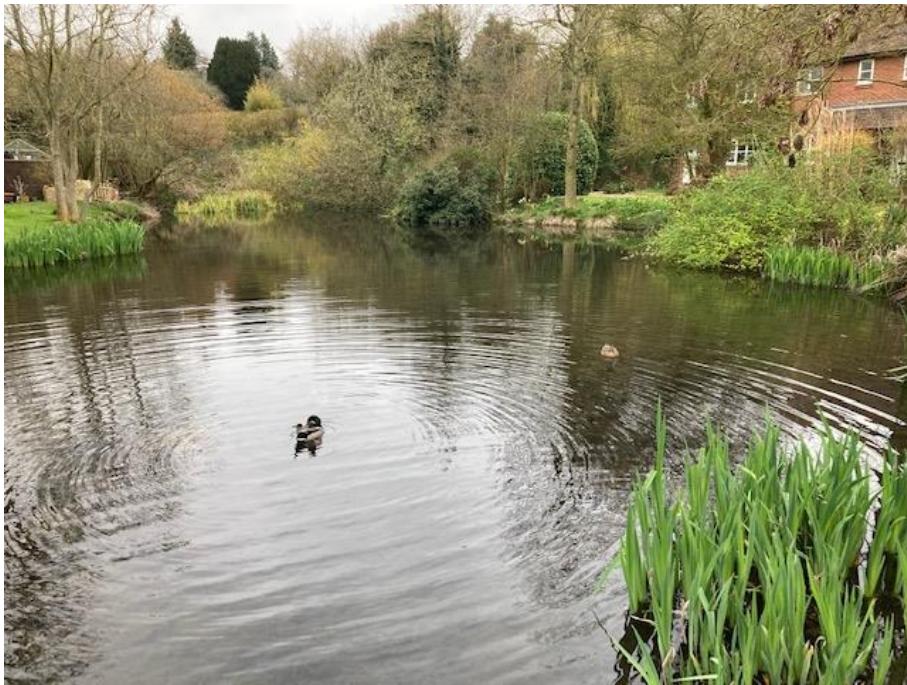
The effective upstream limit of the stream is located at a small pond in Ewelme. Several small streams enter this pond, with varying degree of flow surety. The pond has been historically extensively modified, with a range of marginal habitats resulting. The upwelling of springs in the bed of the pond is clearly marked by a number of silt free gravel areas.

**Figure 2: Pond at the effective perennial head of the stream**

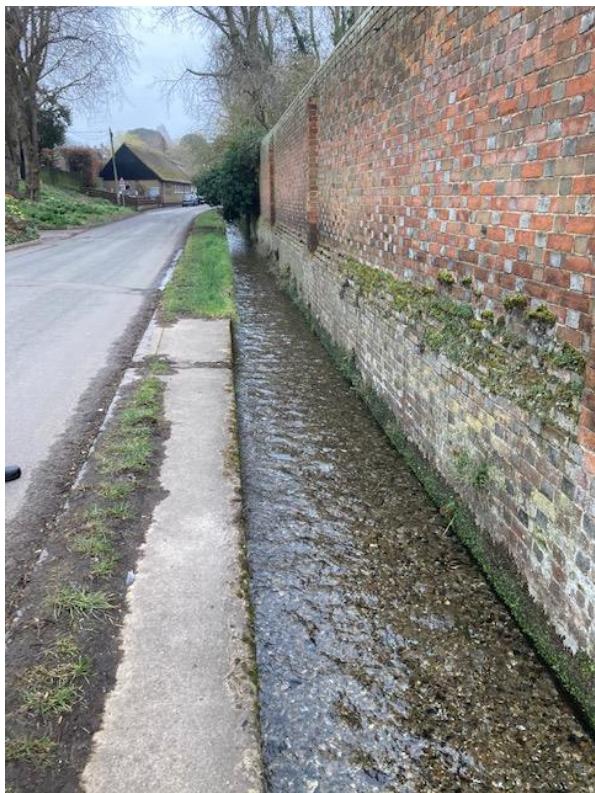
Downstream of the pond, the brook had a generally steep gradient, and a gravel dominated substrate within a heavily modified channel alongside the main road. The presence of shading walls along the LB and the lack of suitable marginal habitat combined to restrict the abundance of instream vegetation

**Figure 3: Channel within the village. Note gravel substrate and lack of vegetation**

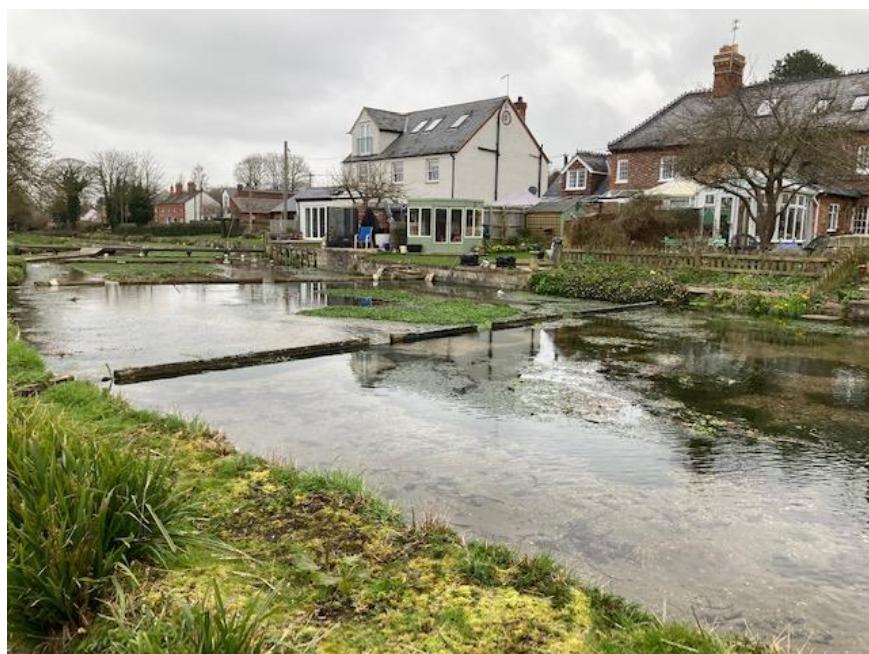
There are some tensions regarding management of the beds, with the desire to 'tidy' the habitat leading to the unnecessary and damaging removal of sections of timber (Large Woody Debris - LWD) from the channels. Retention of LWD and the creation of brushwood berms would increase stream velocity locally, allow the development of marginal plants, promote scouring of gravel to the advantage of spawning brown trout and increase instream cover.

**Figure 5: Cress beds**

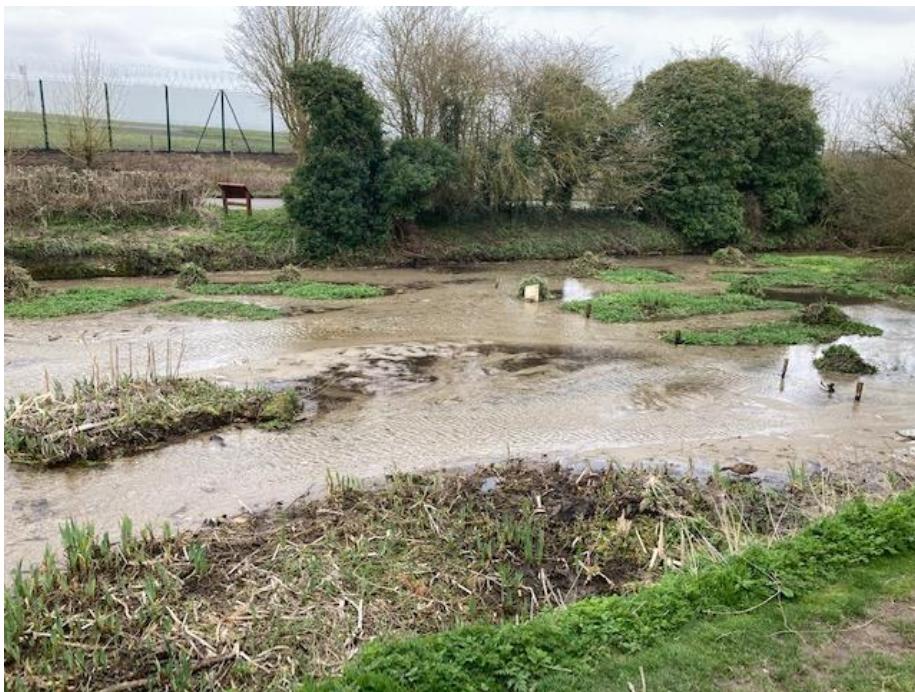
Leaving the village of Ewelme, the stream passes through a small nature reserve downstream of the site of an old mill. The channel is very wide here with the development of a series of braided channels beginning. The periodic removal of brushwood, accumulated sediment and growth of emergent/ruderal vegetation has prevented the establishment of vegetated margins and islands.

**Figure 6: Downstream of the site of the old mill showing the partial development of vegetated berms and a braided channel**

Downstream of the site of the former Ewelme mill, a decision should be made to either consolidate the developing silt berms using brushwood bundles or to allow the site to develop naturally with no intervention

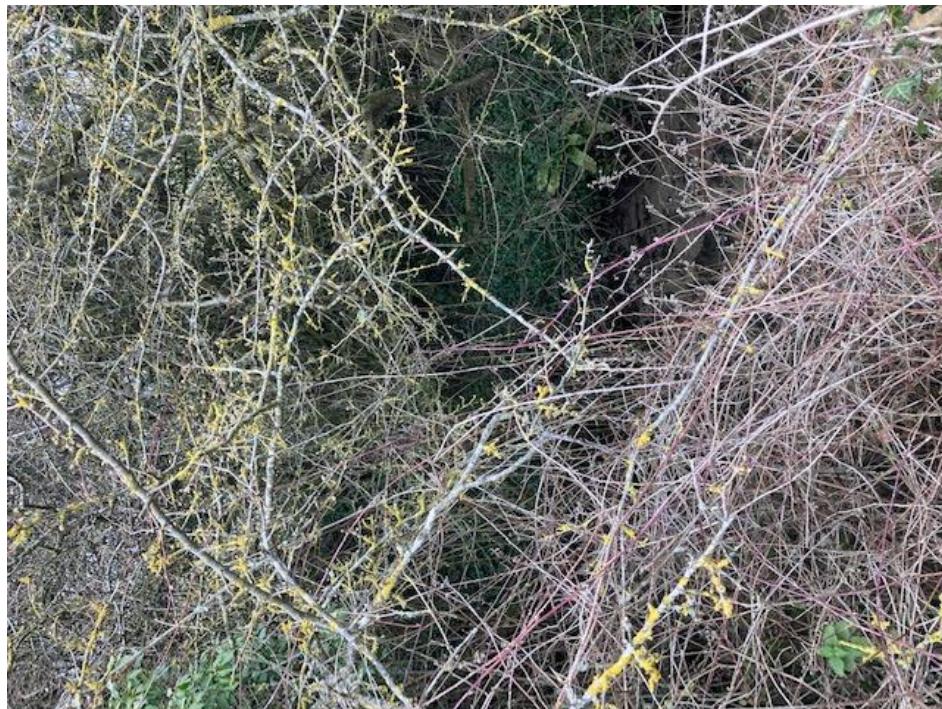
The channel runs alongside the main road adjacent to Benson airbase. There is a short section of very heavily shaded channel; in the summer very little light penetrates due to the extensive growth of bramble *Rubus fruticosus* and other plants. Whilst providing good cover from predation for fish, the reduction in ambient light has limited the growth of instream and marginal vegetation.

**Figure 7: Dense bramble and thorn cover on LB of roadside channel**

Subject to resources, it may be beneficial to consider some cutting of the dense bramble cover on the LB of the stream opposite Benson airbase to reduce shading of the channel

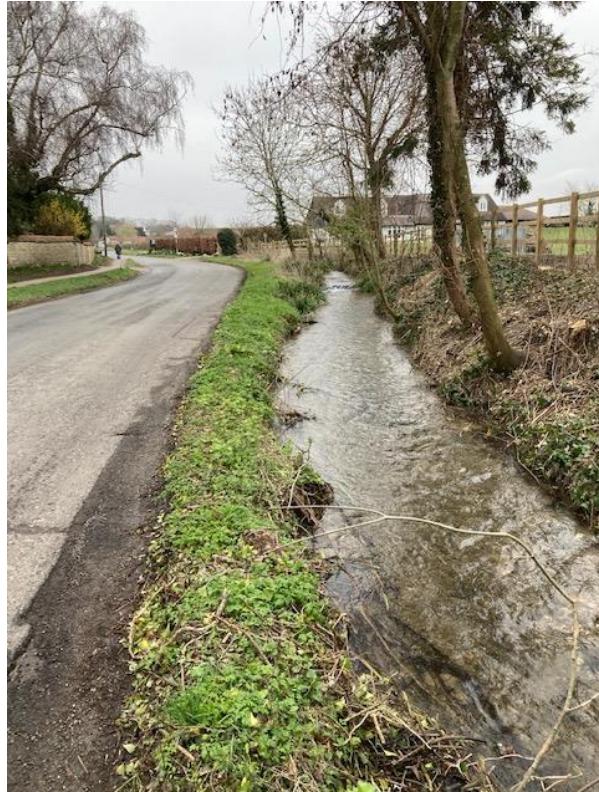
Mirroring this over-shading, a section of downstream channel had been over-manicured, with the total removal of riparian cover alongside a garden/small field. This lost cover had significantly devalued habitat on this short section of stream. There was also some significant RB erosion which threatened to undermine the road carriageway.

**Figure 8: Overcutting on the LB of the channel reducing cover. Note also the closeness of the road to the stream**

Allow regrowth along the over-cut bank shown in Figure 8, or develop a planting plan for marginal vegetation to replace lost cover. Work with the local authority to prepare a scheme to protect both the river channel and the adjacent road

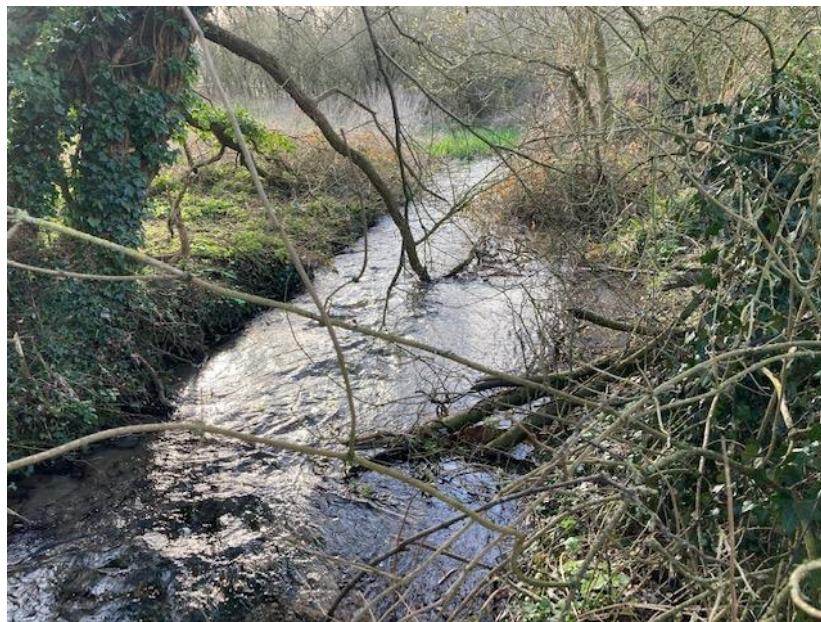
Further downstream and just before the entry into Benson village, a section of more natural channel provided a blue print for habitat quality elsewhere. Good bankside cover and excellent instream habitat, with abundant LWD combined to make this one of the more valuable sections of the stream with regard to its ecology.

**Figure 9: Above Benson showing good instream habitat and bankside cover**

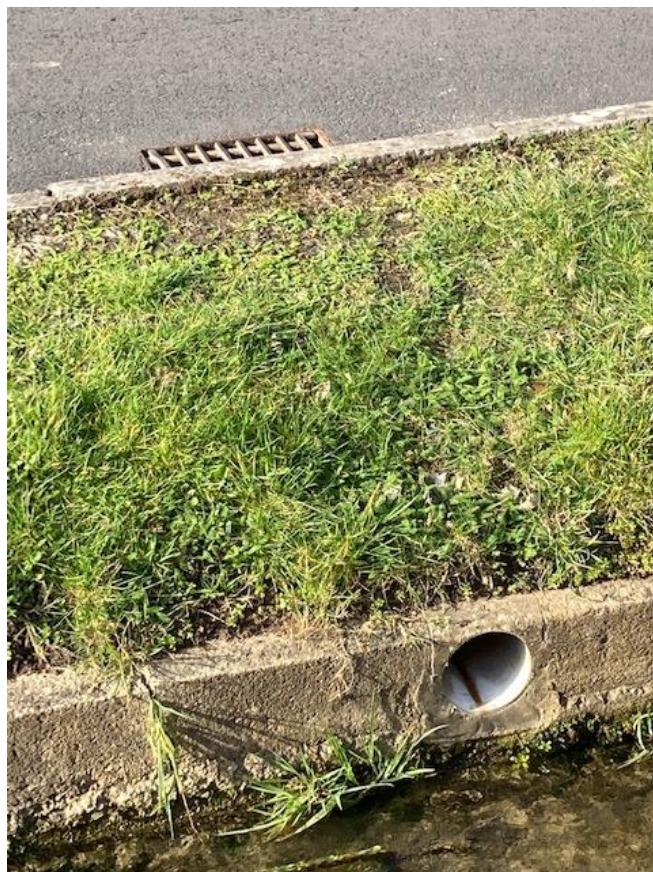
Road run-off to the channel is an issue throughout its length with rudimentary grips and gullies posing a risk of mobilised sediment and pollutants entering the stream.

**Figure 10: Road run-off piped directly into the stream**

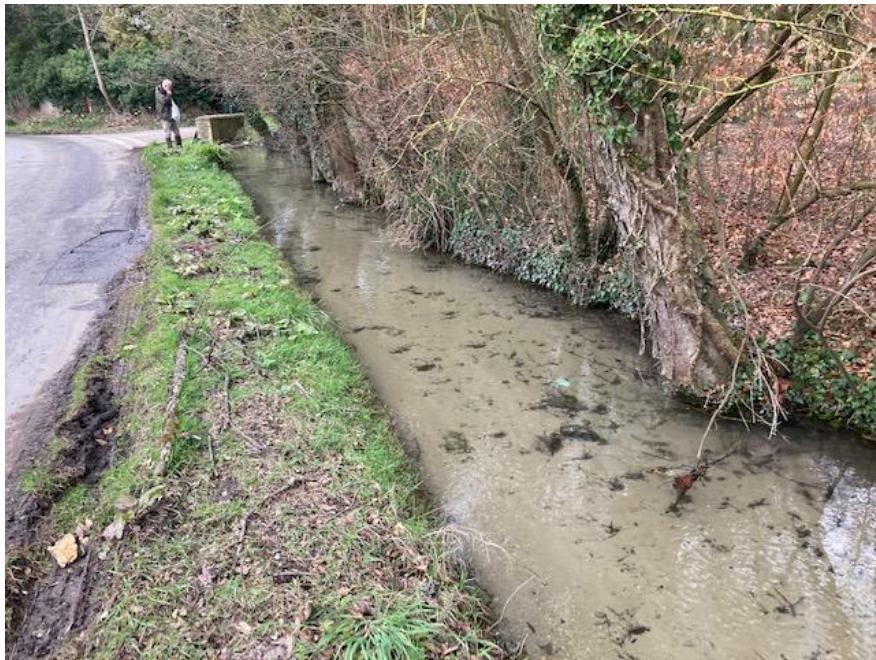
**Figure 11: Accumulation of sand and fine sediment in an over-wide uniform section of channel**

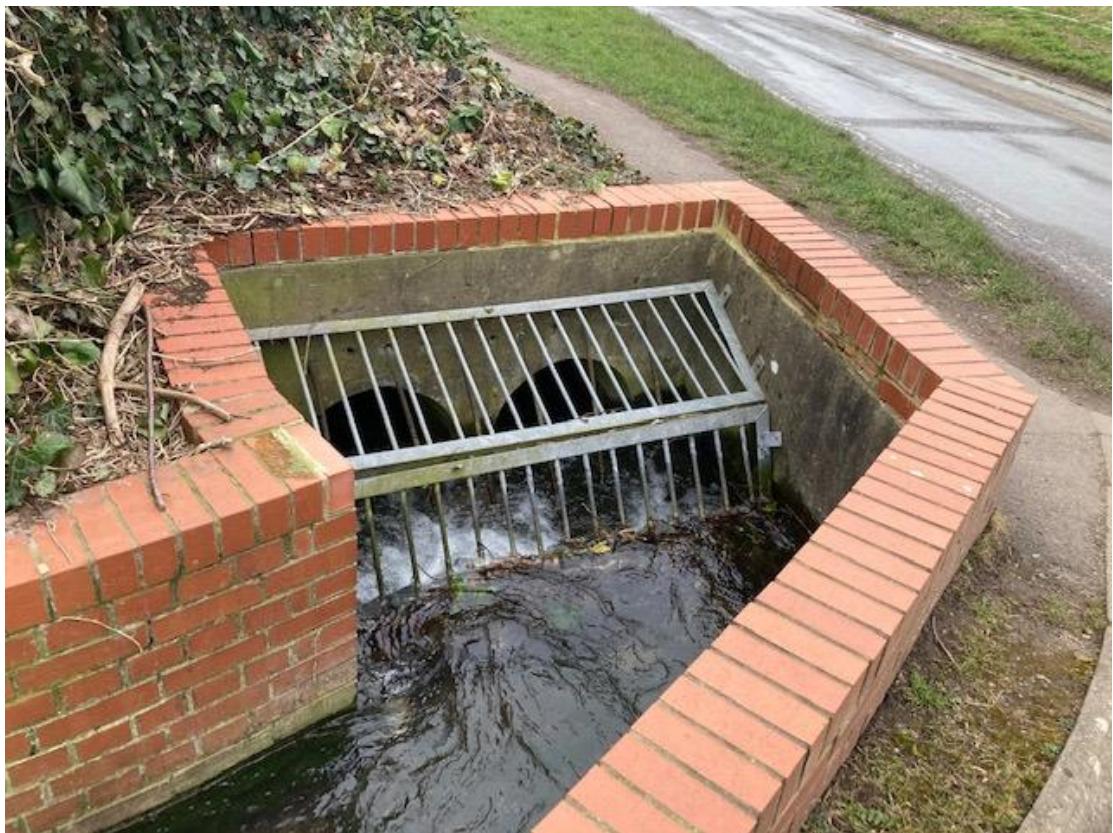
Further extensive modification of the channel has taken place alongside the main Benson run-way with a 266m long section of the river culverted due to the risk of bird strike to aeroplanes. Interestingly, the channel enters twin pipes under the culvert with the flow split nominally equally between the two. However on exit at the downstream end, the flow has become totally concentrated into one pipe, strongly suggesting some failure/and or blockage in one of the pipes.

**Figure 12: Twin pipes forming a culvert alongside the main Benson runway**

The culverted section of channel alongside the airfield could potentially be ‘skylighted’ by replacing the enclosed round culverts with a square section culvert with expanded mesh roof. It is not likely that this option would prove to be financially acceptable but may be possible in the event that the culverts need repair or replacement

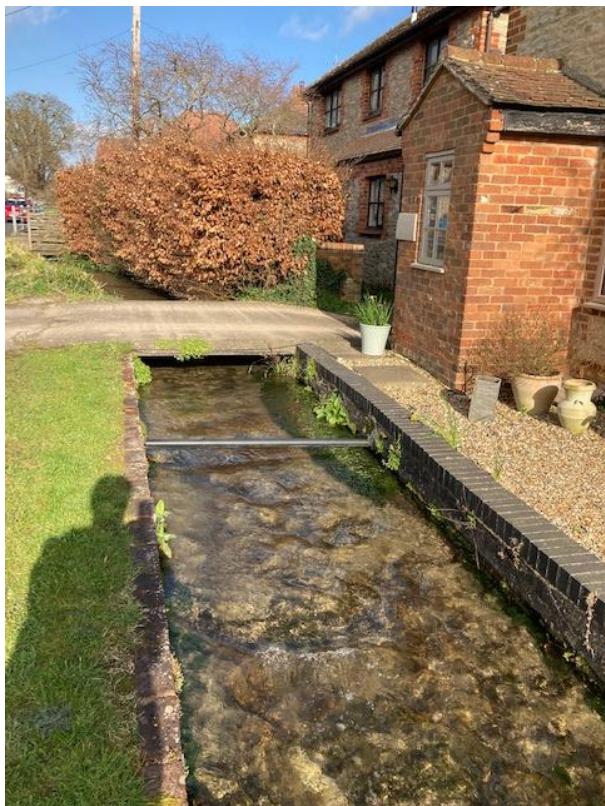
For much of the reach through the village of Benson the stream is heavily modified, running between residential property and the main road. Despite a general lack of marginal vegetation, instream habitat was often good, with significant stands of water crowfoot and abundant clean gravel substrate. Connectivity along the stream was also generally good, with most bridges/culverts allowing for passage of fish. There were however two small weirs/low impoundments at the upstream end of this reach that although not preventing fish movement may slightly impede it, leading to increased rates of predation. Brown trout were observed in this reach of the river.

**Figure 13. Channel within Benson village. Note good instream habitat but limited marginal vegetation**

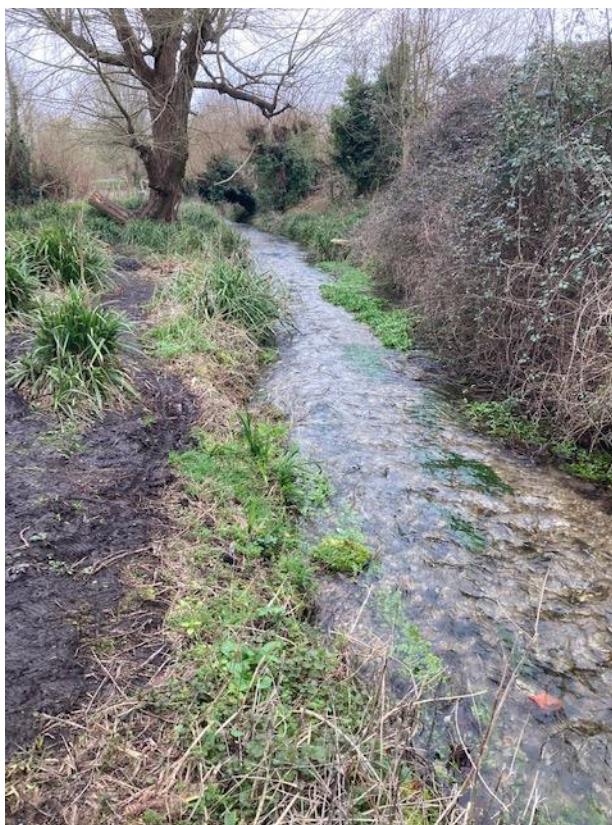
Towards its downstream limit the brook flowed through a small nature reserve. Habitat quality was generally much improved here with semi-natural banks. There was however some evidence of over-management, particularly of LWD which could usefully be left in place or indeed selectively introduced to the advantage of the stream's ecology.

**Figure 14: Generally good habitat quality in the downstream nature reserve**
