**HABITAT ADVISORY VISIT TO THE EWELME  
STREAM, EWELME/BENSON OXFORDSHIRE  
UNDERTAKEN BY VAUGHAN LEWIS,  
WINDRUSH AEC LTD ON BEHALF OF WILD  
TROUT TRUST  
MARCH 2021**

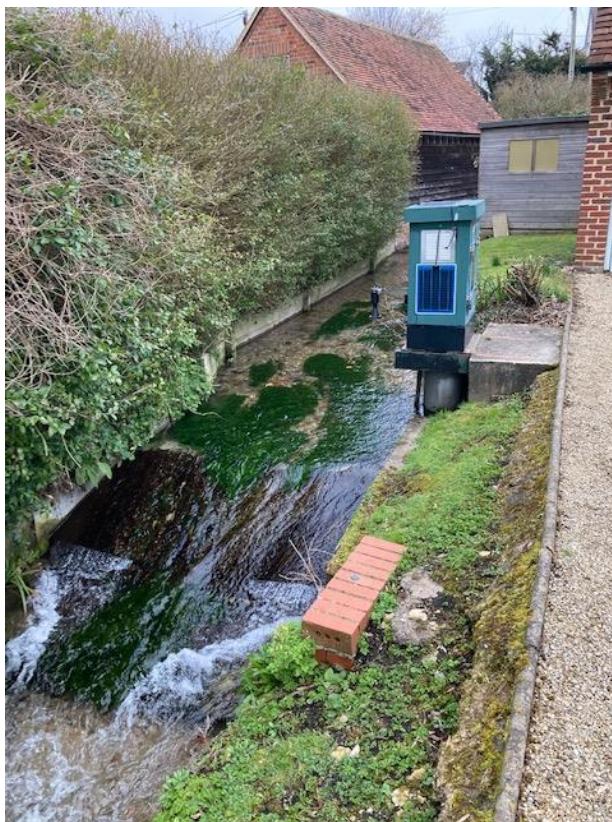
**Figure 4: EA gauge weir**

Flows in the Ewelme Stream are recorded at an Environment Agency (EA) gauging weir. Commissioned in 1970 it has recorded flow data continuously, apart from a 4 year break (1976-1980). Mean discharge for this period is  $0.045\text{m}^3/\text{sec}$ . Flow is typical of a chalkstream, being relatively steady albeit interspersed with some well-recorded flood events and droughts.
